FINAL REPORT

PEDESTRIAN WIND ASSESSMENT UNIVERSITY OF LETHBRIDGE LETHBRIDGE - ALBERTA

Project Number: #0940066

May 8, 2009

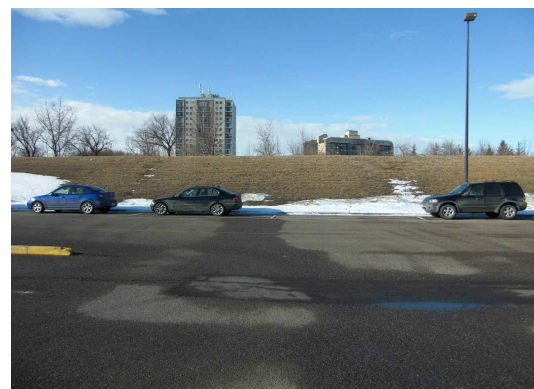
Most areas in the parking lots are exposed to the winds from the prevailing westerly directions. During the site visit by RWDI, wind speed measurements were taken at pedestrian level at Locations T₁ through T₆ to obtain an indication of the relative windiness at the different measurement areas. The highest reading was obtained at T₁, using this as a reference, the averaged wind speeds decreased to the west, closer to the berm (see Figure 1 and Image 6). At T₃, the wind speeds are about 40 % lower than T₁.

Image 6 – Existing Landscape Berm west of Parking Lot

Similarly, the wind speed decreased westward, from T₄ to T₆. The readings at T₄ and T₆ are 30 % and 70 % lower than that at T₁, respectively. These locations are protected by the existing coniferous trees located at the top of the berm in that area. This series of measurements illustrates the effectiveness of the adjacent coniferous trees to reduce the wind speeds in the area. If this reduction in the wind speed could be applied to the remaining parking lots by adding the proposed trees within the parking lot areas shown in Figure 3, improved wind conditions suitable for walking or better could be expected year round.

We recommend further study in the water flume to visualize the wind patterns causing these windy conditions in the parking lot and confirm the effectiveness of the conceptual wind control features.

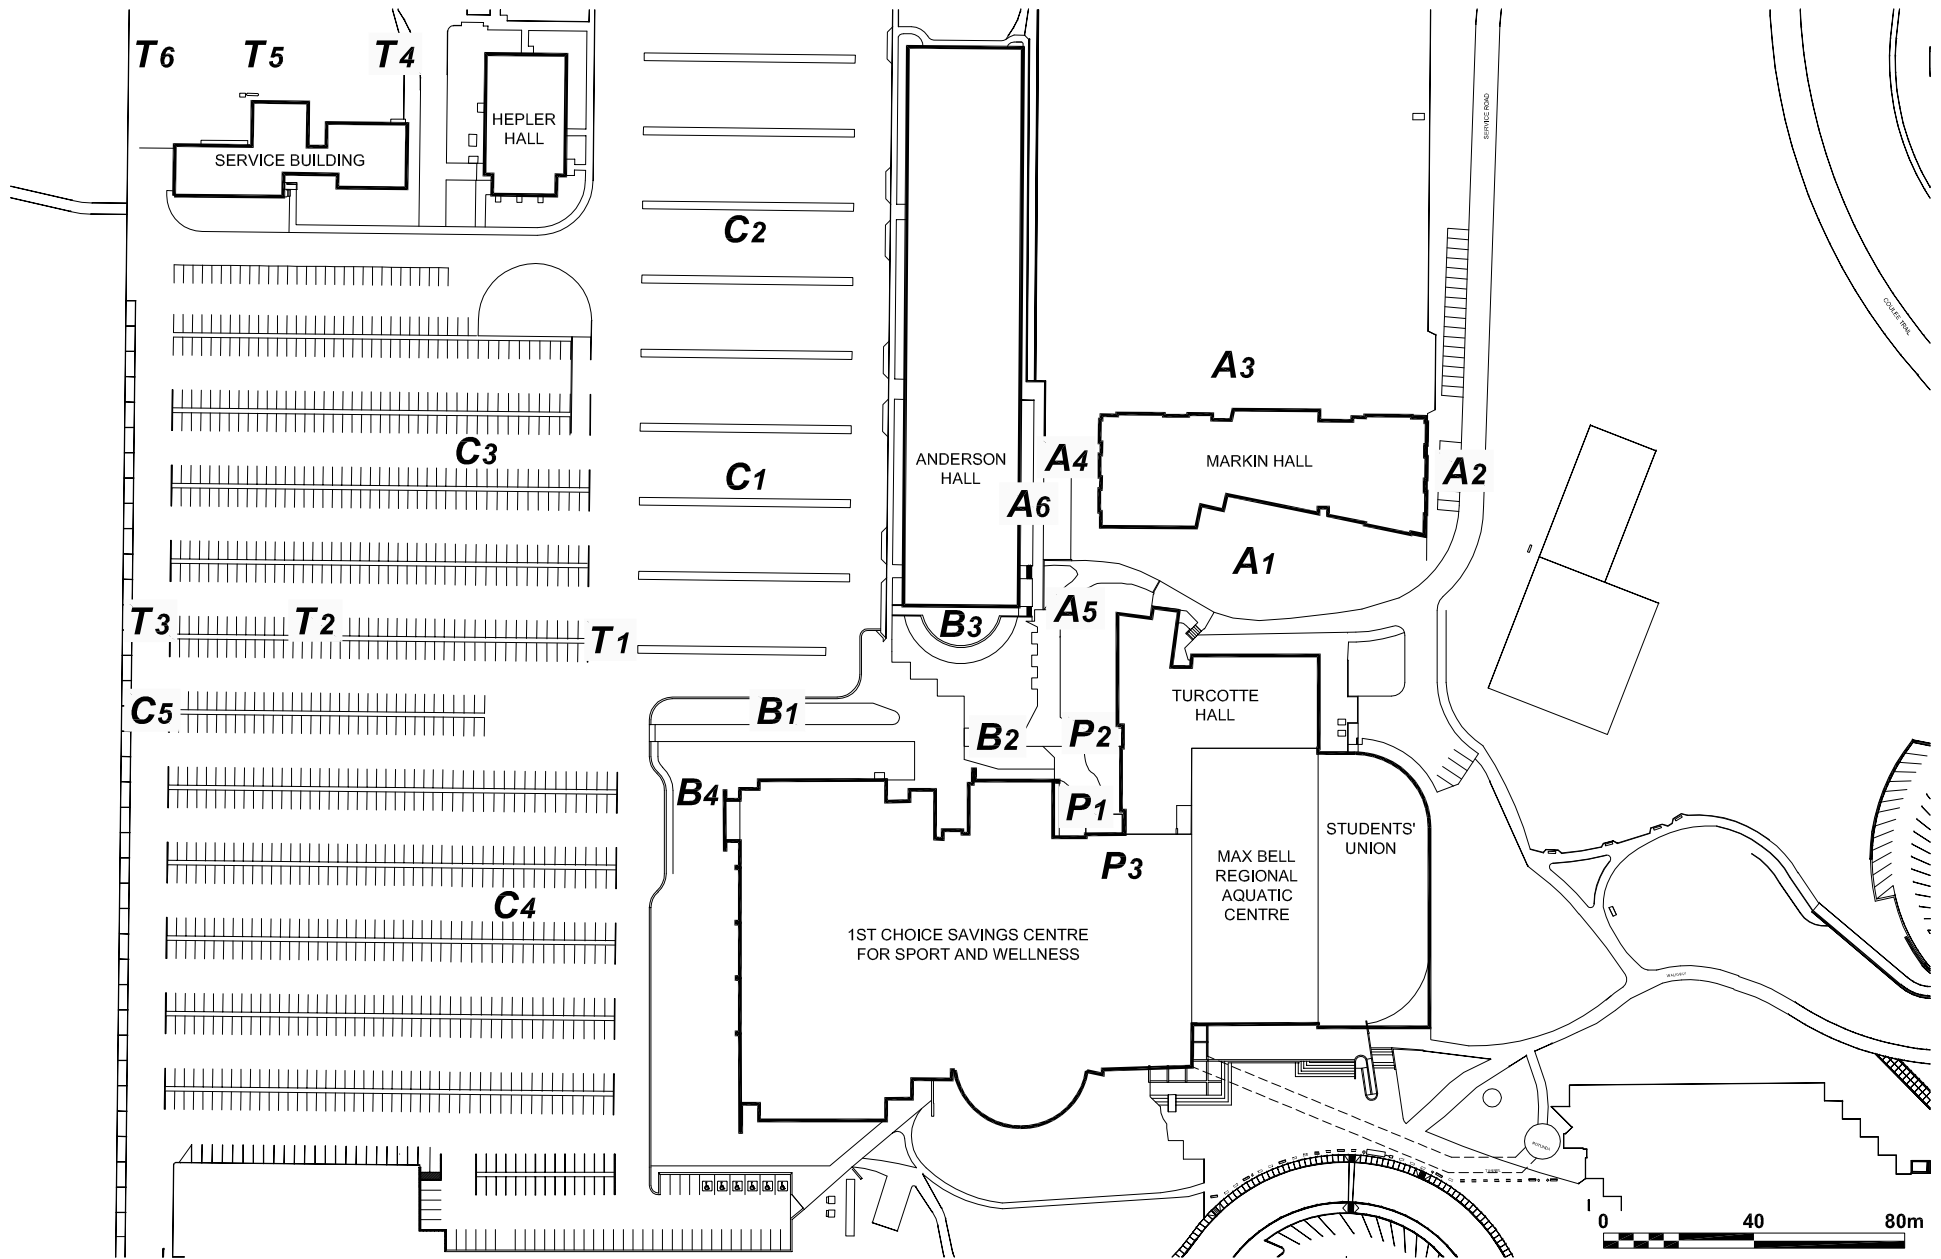
Drawn by: ACM	Figure: 1

The following describes the anticipated pedestrian wind conditions at notable areas (see Figure 1) on and around the study site.

There are operational problems at the north handicap doorway to the 1st Choice Savings Centre (P_1) and the main entrance to the Turcotte Hall (P_2). These locations are identified in Figure 1. It is our impression that the problems are related to air infiltration and wind pressure at the doors.

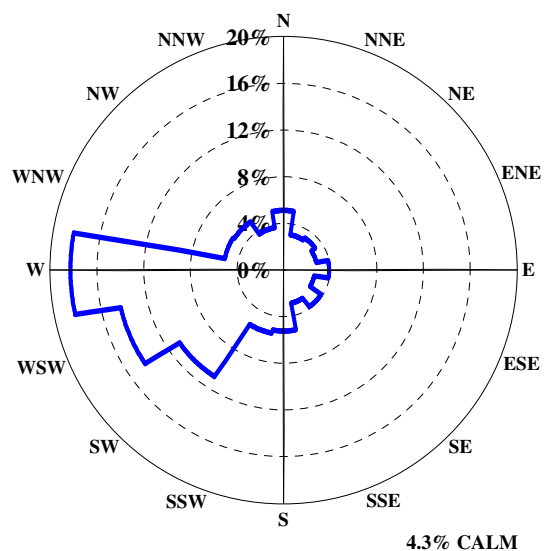
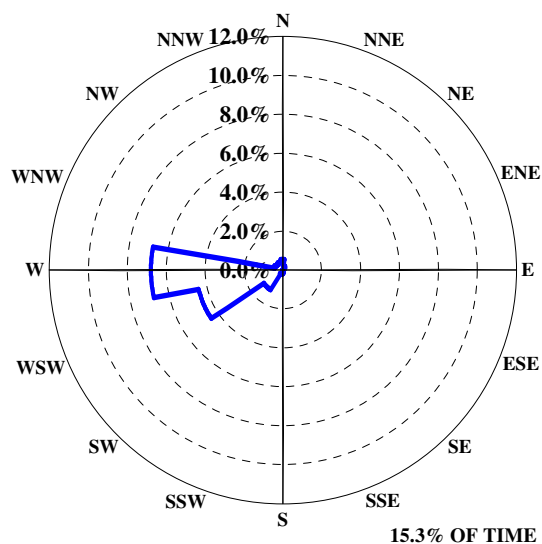
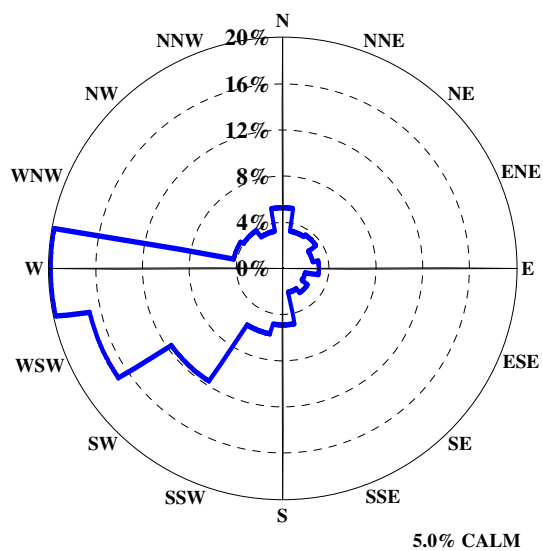
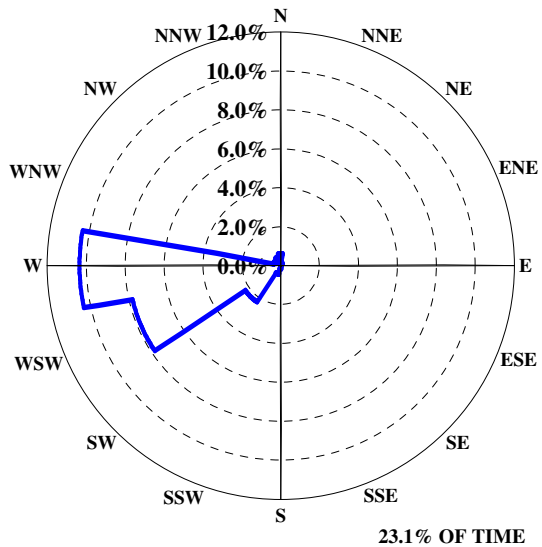
Wind statistics recorded at the Lethbridge Airport between 1953 and 2006 were analysed for the summer (May through October) and winter (November through April) seasons. Figure 2 graphically depicts the distributions of wind frequency and directionality for these two seasons. The upper-left wind rose identifies the summer wind data, while the lower-left wind rose is the winter wind data. Winds from the west, west-southwest and southwest directions are predominant in both the summer and winter seasons, when all winds are considered. Calm winds occur for 4.3 % of the time in the summer and 5 % of the time in the winter.

Strong winds of a mean speed greater than 30 km/h measured at 10 m above grade at the airport occur for 15.3 % and 23.1 % of the time during the summer and winter seasons, respectively. Strong winds from the west and west-southwest directions are prevalent for both seasons, as demonstrated by the two right-hand wind roses in Figure 2. Based on the above analysis of wind data and the potential for local wind acceleration caused by the proposed building, winds from the west-southwest and west directions are considered important in the assessment of pedestrian wind conditions, although all other wind directions have been considered in our analysis.
